LAWRENCE
LIVERMORE
NATIONAL
LABORATORY

LLNL-TR-648143

A Visual Description of the Concrete Exterior of the Cactus Crater Containment Structure

October 2013

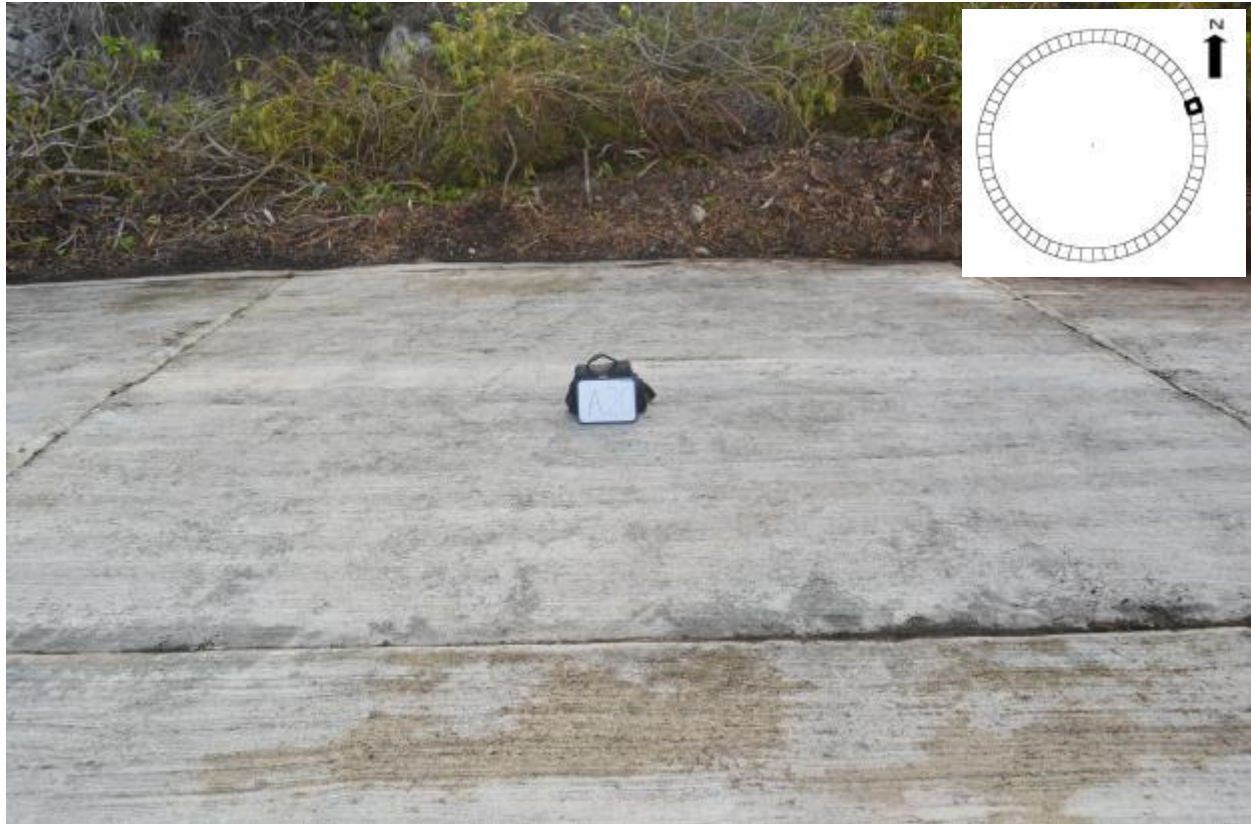
CAP SECTION LOCATION: Panel A21

No significant or obvious interior cracks extending across the top of the panel. The panel has a relatively rough appearance. Minor spalling of concrete observed along the bottom seam adjoining the keywall, and in the upper left-hand corner of the panel. Rooting vegetation removed from along the seams. A scrub tree overgrowing the keywall was cut down, and the stump removed.

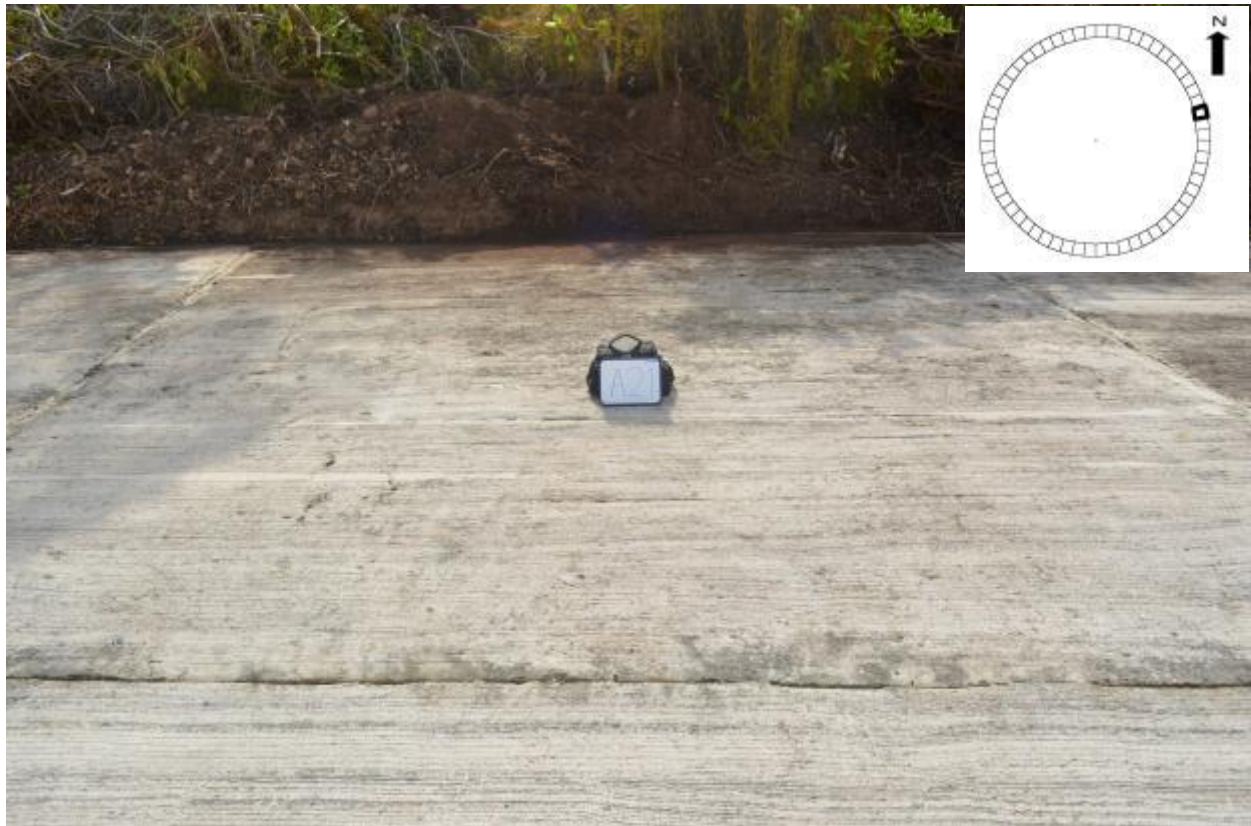
CAP SECTION LOCATION: Panel A22

No significant or obvious interior cracks extending across the top of the panel. The panel has a rough and weathered appearance. Rooting vegetation removed from along the seams. Minor spalling of concrete observed in the upper right-hand corner of the panel, and in the joint intersecting with panel B21. This panel contains a vertical elevation benchmark.

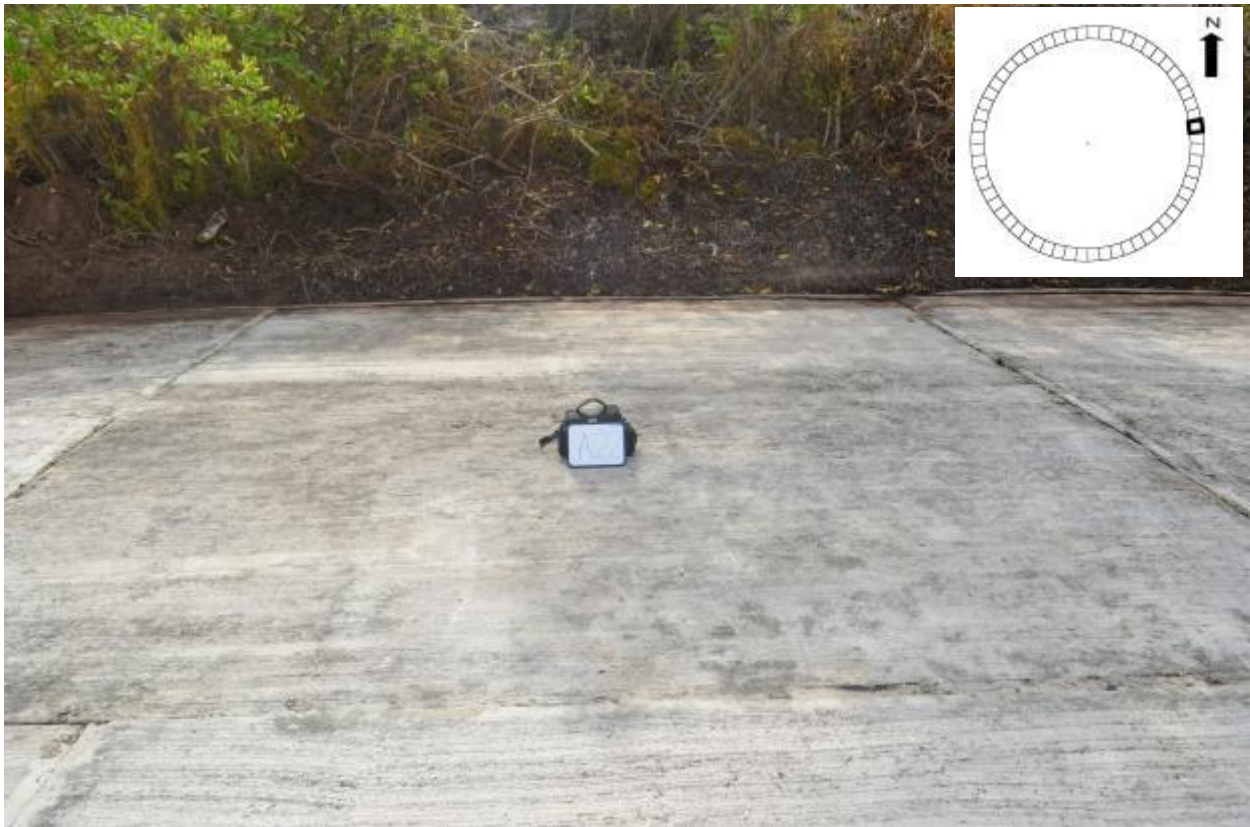
CAP SECTION LOCATION: Panel A23

No significant or obvious interior cracks extending across the top of the panel. The panel has a rough and weathered appearance. Rooting vegetation removed from along the seams.

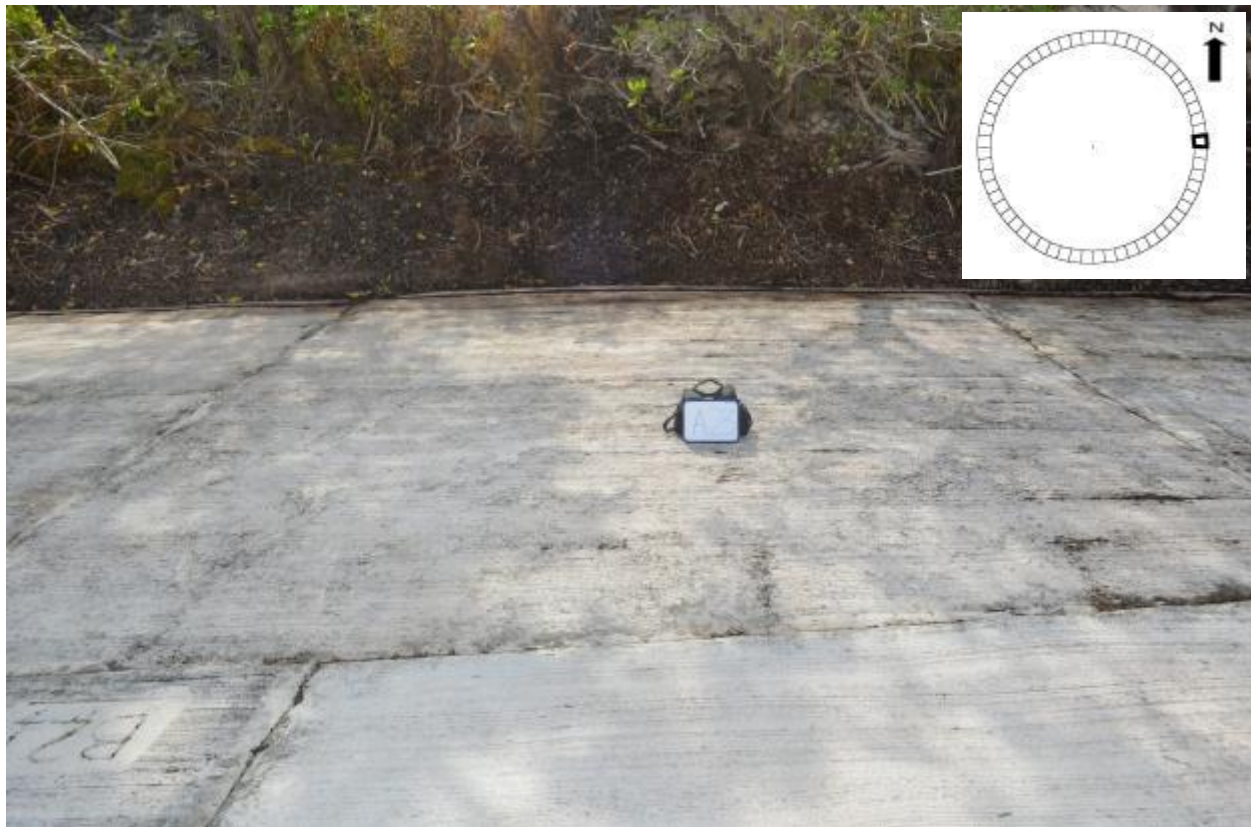
CAP SECTION LOCATION: Panel A24

The panel has a rough and weathered appearance. A significant spall of concrete is visible along the seam adjacent to the keywall (several centimeters deep, and about 80 x 30 centimeters in area).

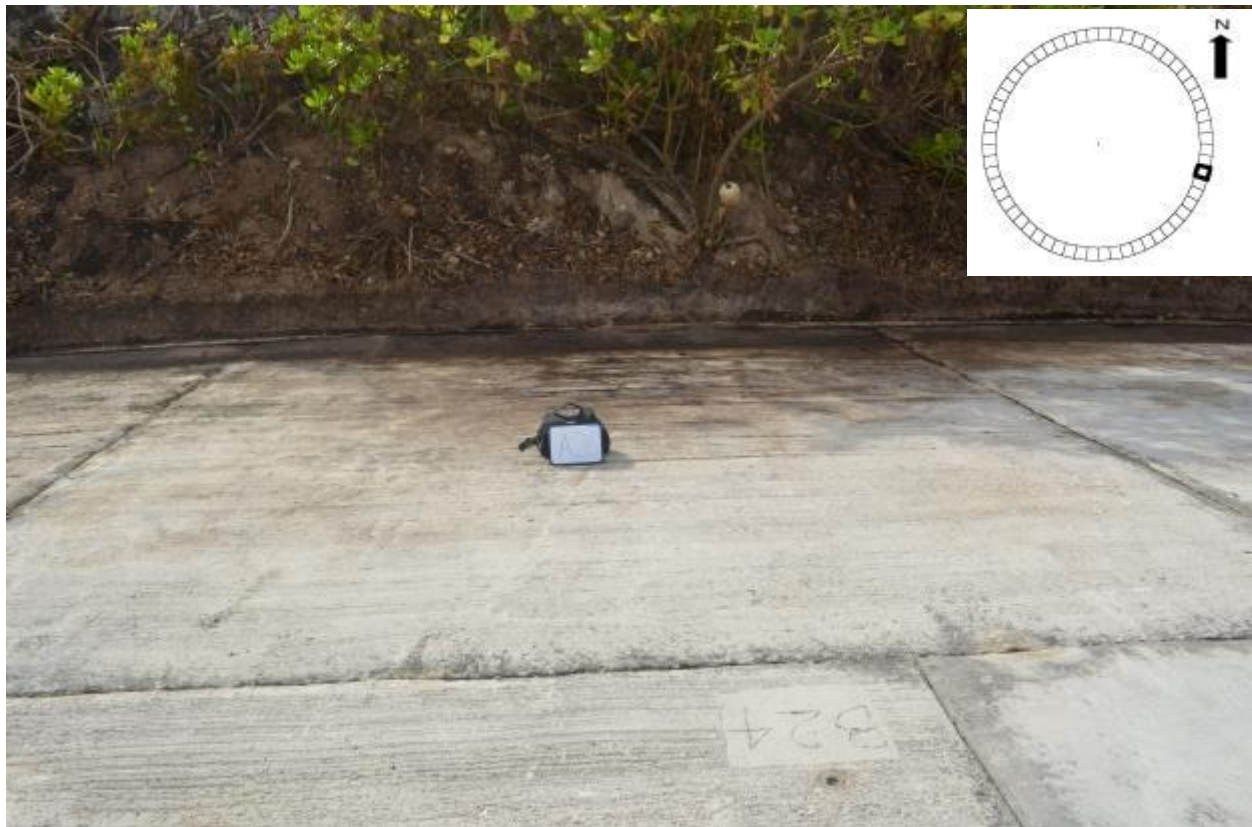
The panel has a rough and weathered appearance. Some spalling of concrete observed along the bottom seam in contact with the keywall and along the top seam, and in the top left-hand corner, of the panel. A scrub tree overhanging the keywall was cut down and the stump removed. A crack was observed on left side of the panel, extending out for a distance of about 4 meters across the panel.

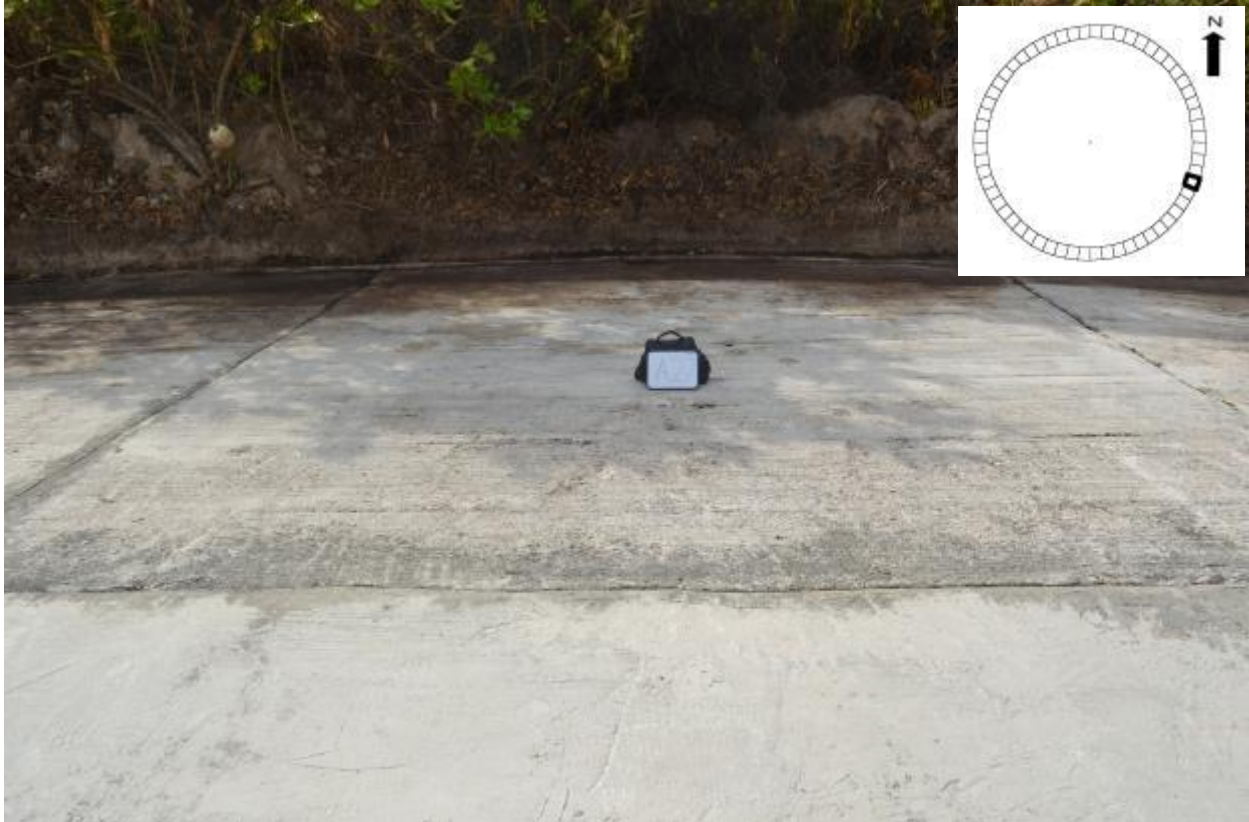
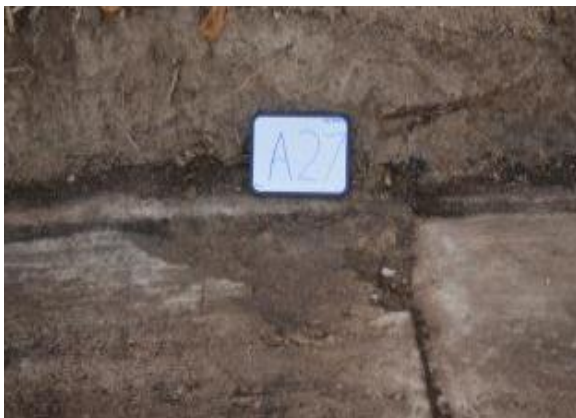
CAP SECTION LOCATION: Panel A27

There are only faint remnants of etched out panel ID marking still visible. There is a significant spall (several centimeters deep, and app. 70 x 40 centimeters in area) in the concrete in the lower left-hand corner, and several other minor spalls appearing both along the bottom and top seams of the panel.

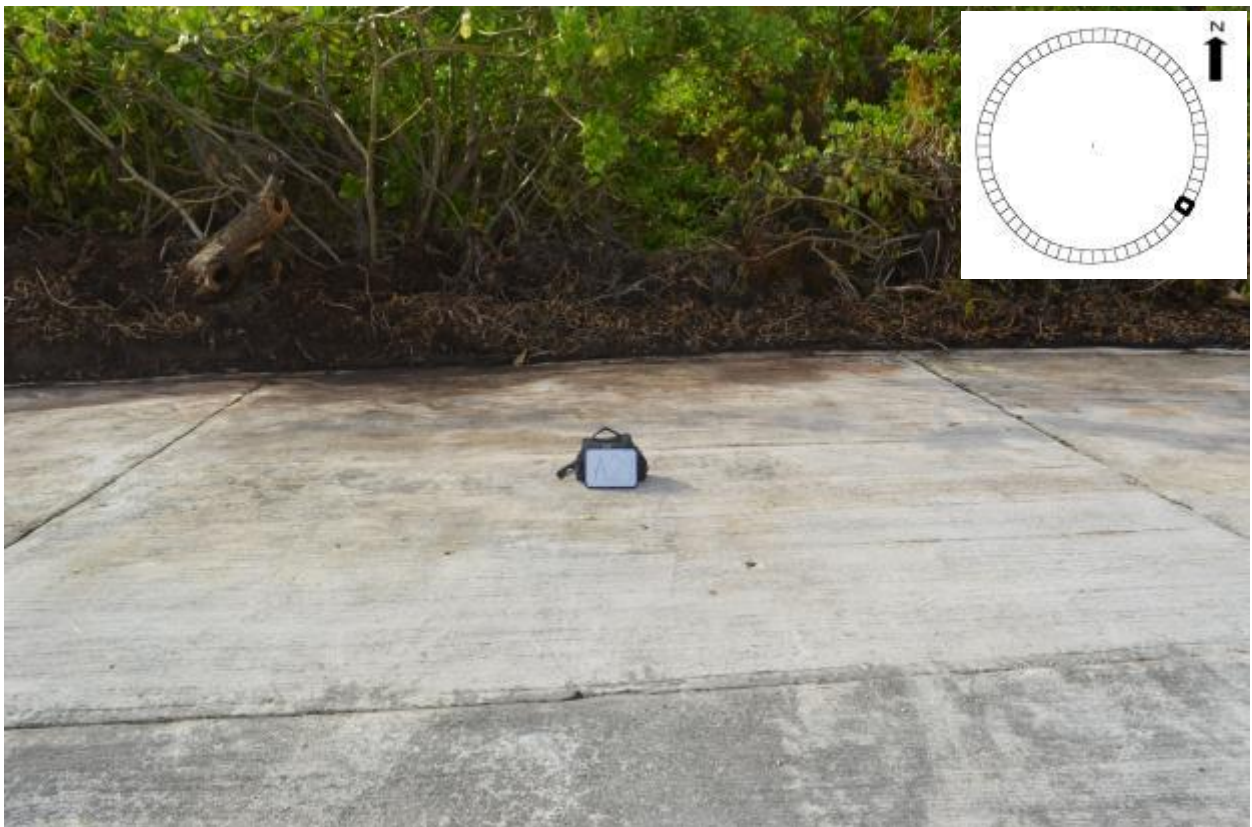
No significant or obvious interior cracks extending across the top of the panel. The panel has a relatively rough appearance. Rooting vegetation removed from along the seams. Some minor spalling of concrete observed in the left-hand corner, and along the top seam, of the panel.

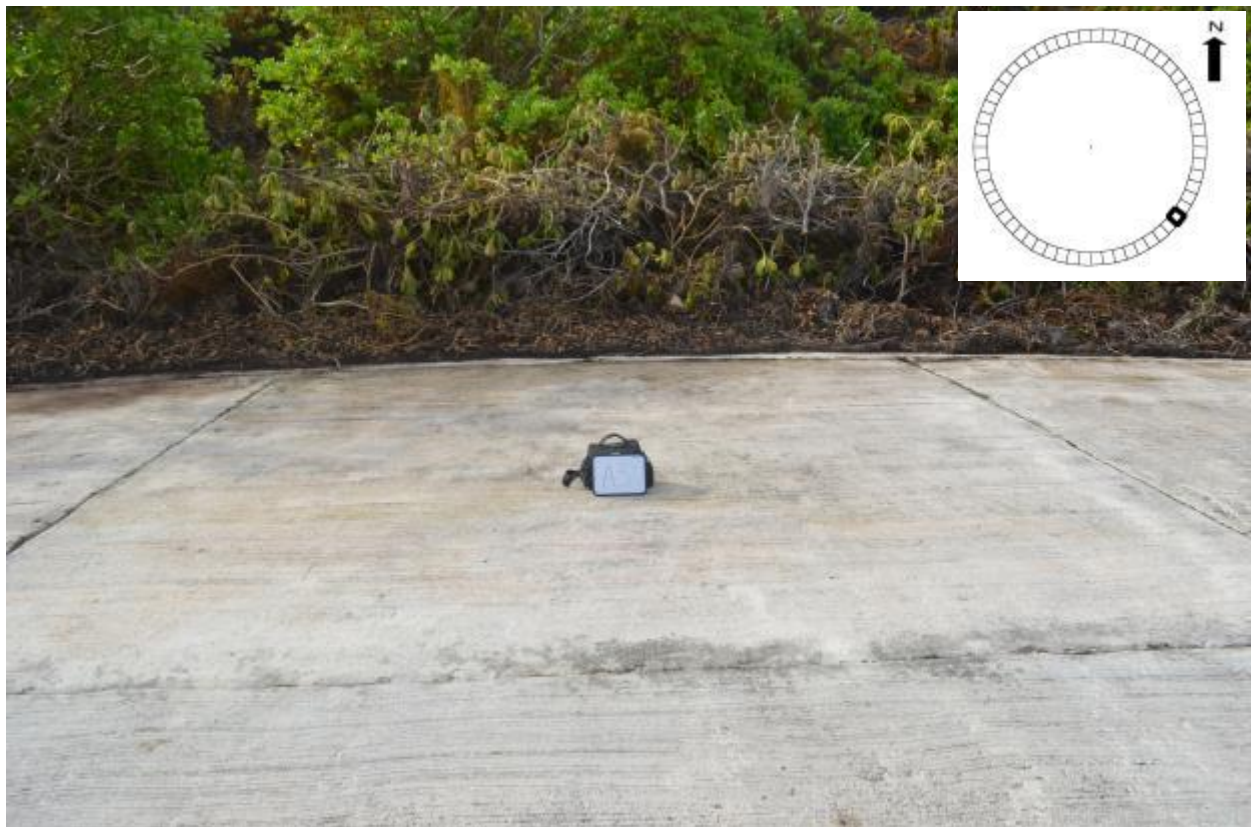
CAP SECTION LOCATION: Panel A30

No significant or obvious interior cracks extending across the top of the panel. Minor spalling of concrete observed in the top and bottom left-hand corners, and in the bottom right-hand corner, of the panel.

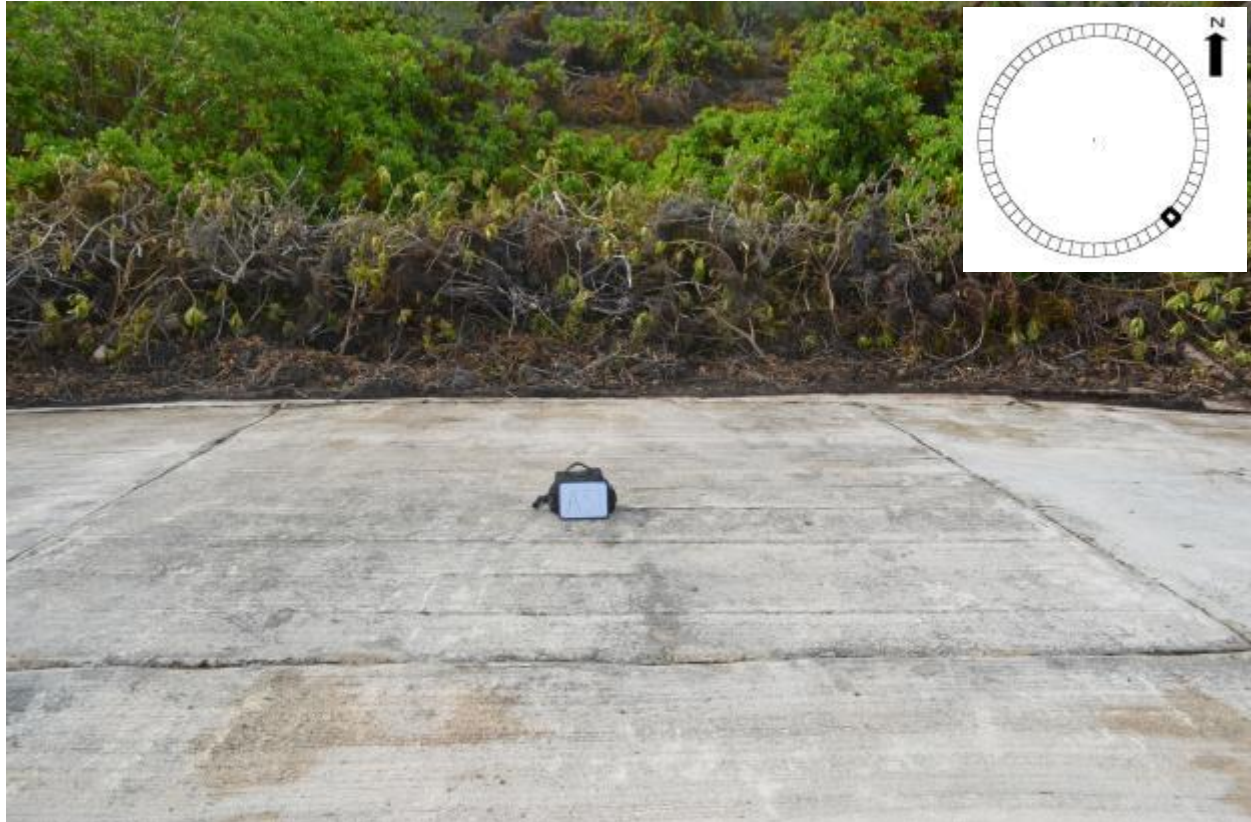
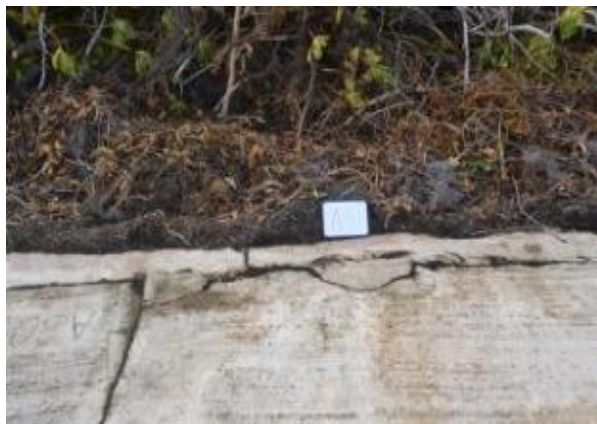
CAP SECTION LOCATION: Panel A31

The panel has a rough and weathered appearance. Rooting vegetation removed from along the seams. Some cracks observed in the lower left-hand corner with minor spalling of concrete in the top right-hand corner of the panel. There is significant spalling and cracks (extending more than 2 meters) appearing in the concrete along the bottom seam adjacent to keywall on the right side of the panel.

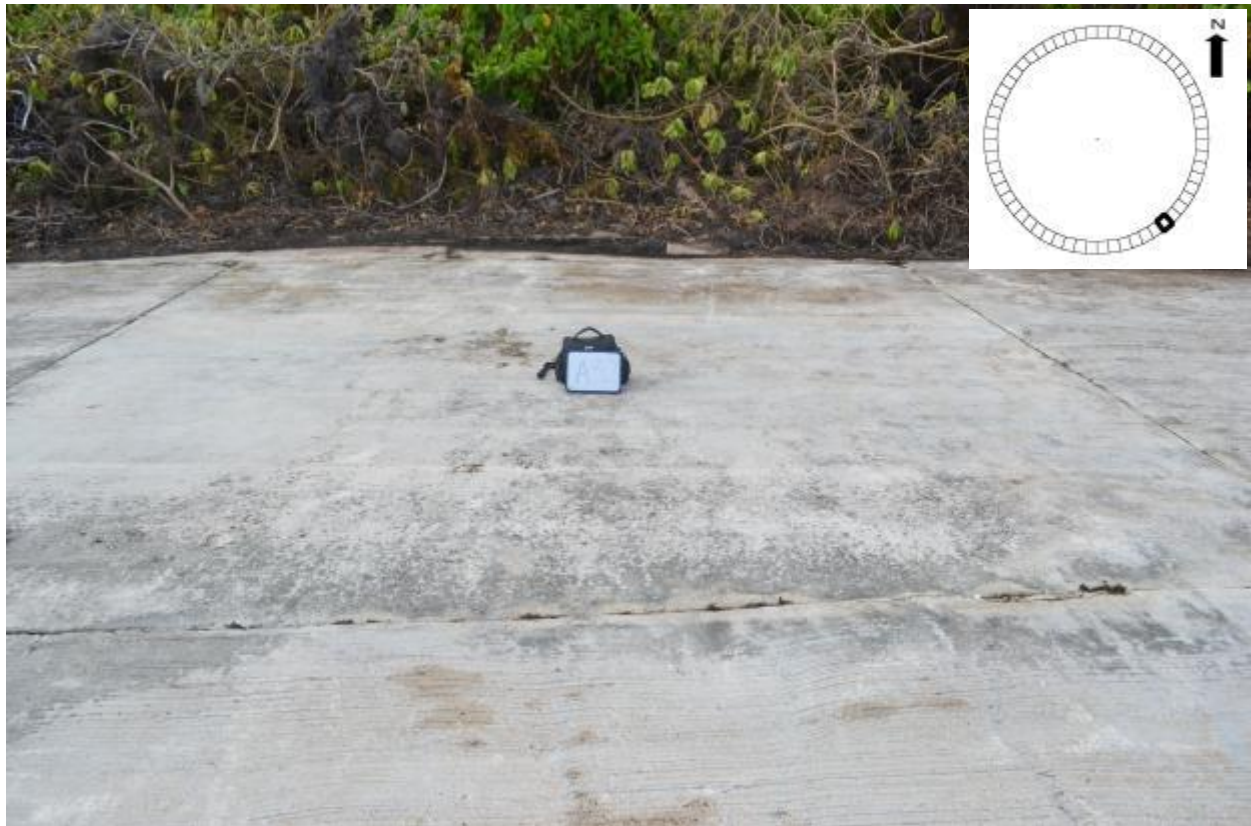
CAP SECTION LOCATION: Panel A32

The panel has a relatively rough appearance. Rooting vegetation removed from along the seams. Some spalling of concrete observed in the lower left-hand corner with chipped out sections to a depth of around 10 centimeters. Also, there was some minor spalling of concrete observed along the top seam and in the upper right-hand corner of the panel. Several cracks were also observed in the keywall.

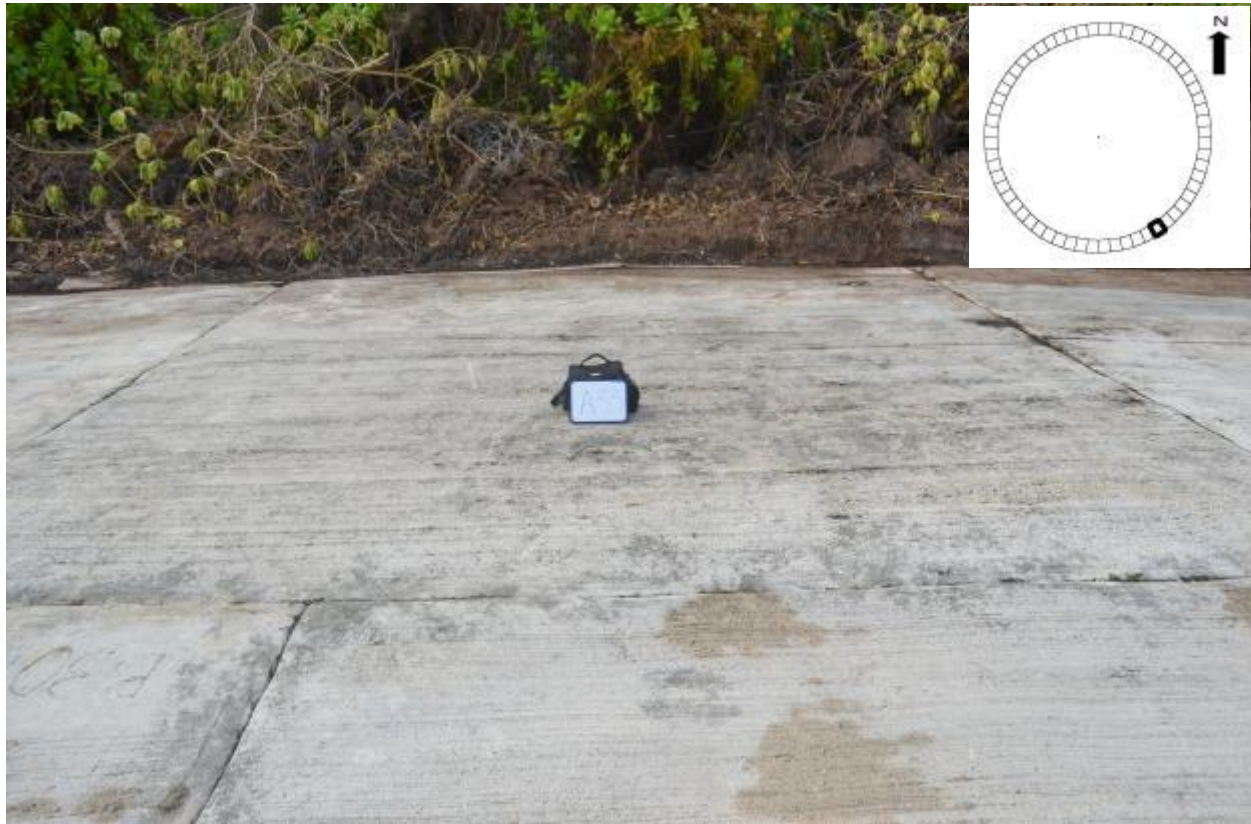
CAP SECTION LOCATION: Panel A33

No significant or obvious interior cracks extending across the top of the panel. The panel has a relatively rough and weathered appearance. Rooting vegetation removed from along the seams.

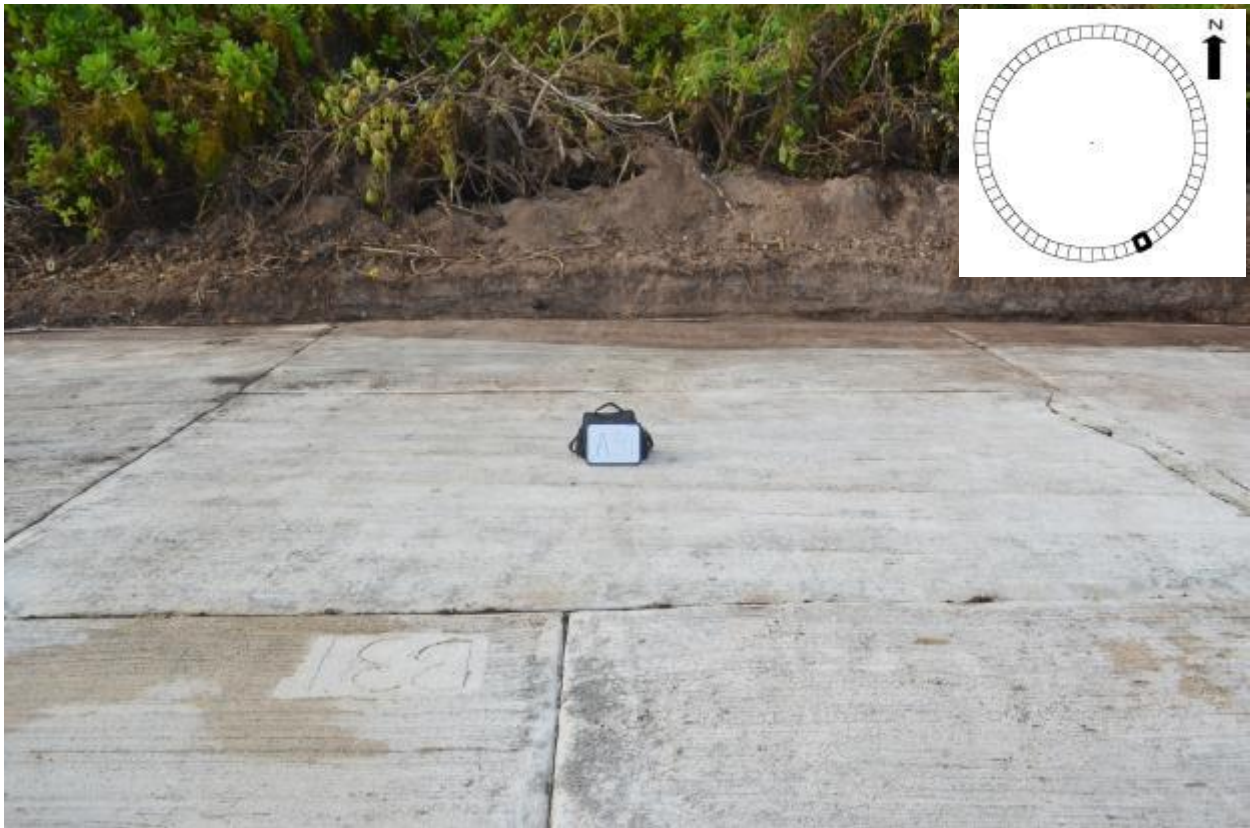
CAP SECTION LOCATION: Panel A34

A crack observed in the concrete extending down from the top of the panel – located about 20 to 25 centimeters inside the left edge of the panel and intersecting with the seam about half way down the panel.

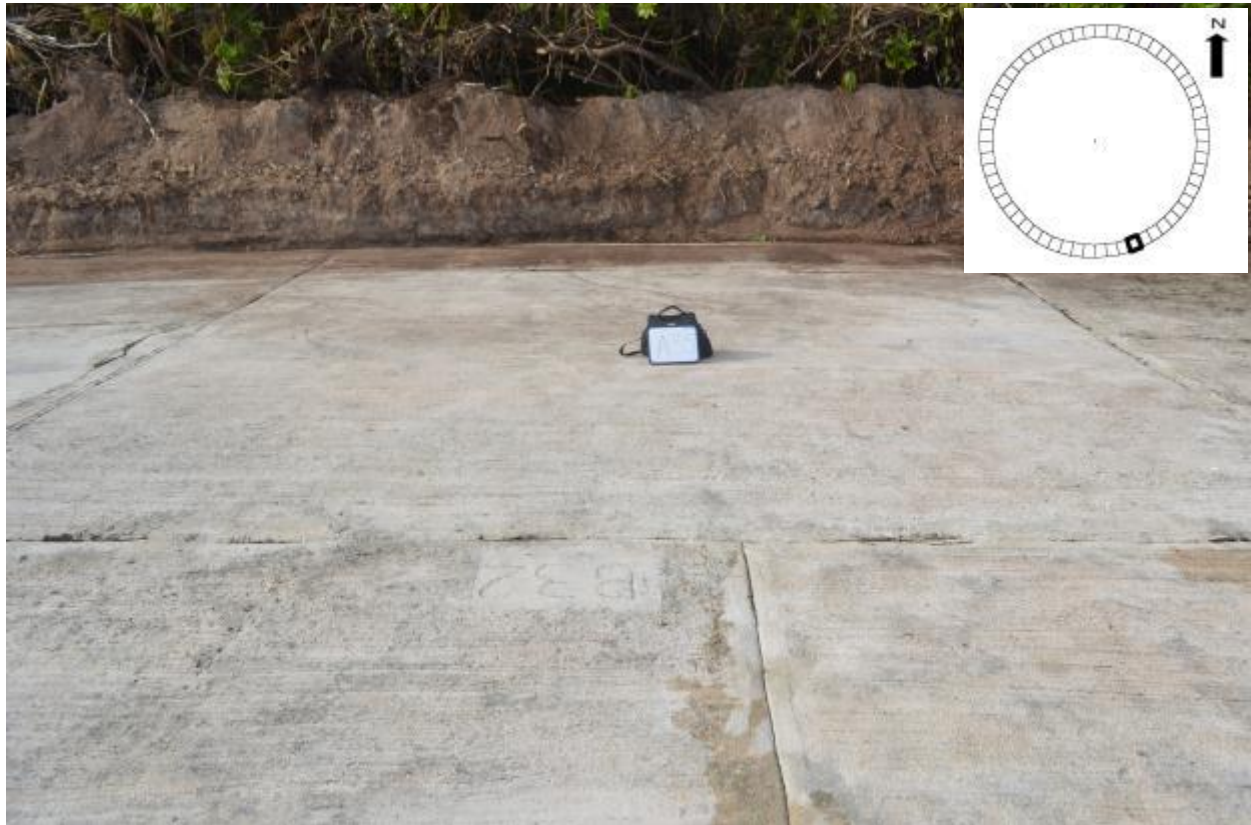
CAP SECTION LOCATION: Panel A35

No significant or obvious interior cracks extending across the top of the panel. The panel has a relatively rough appearance. Rooting vegetation removed from along the panel seams.

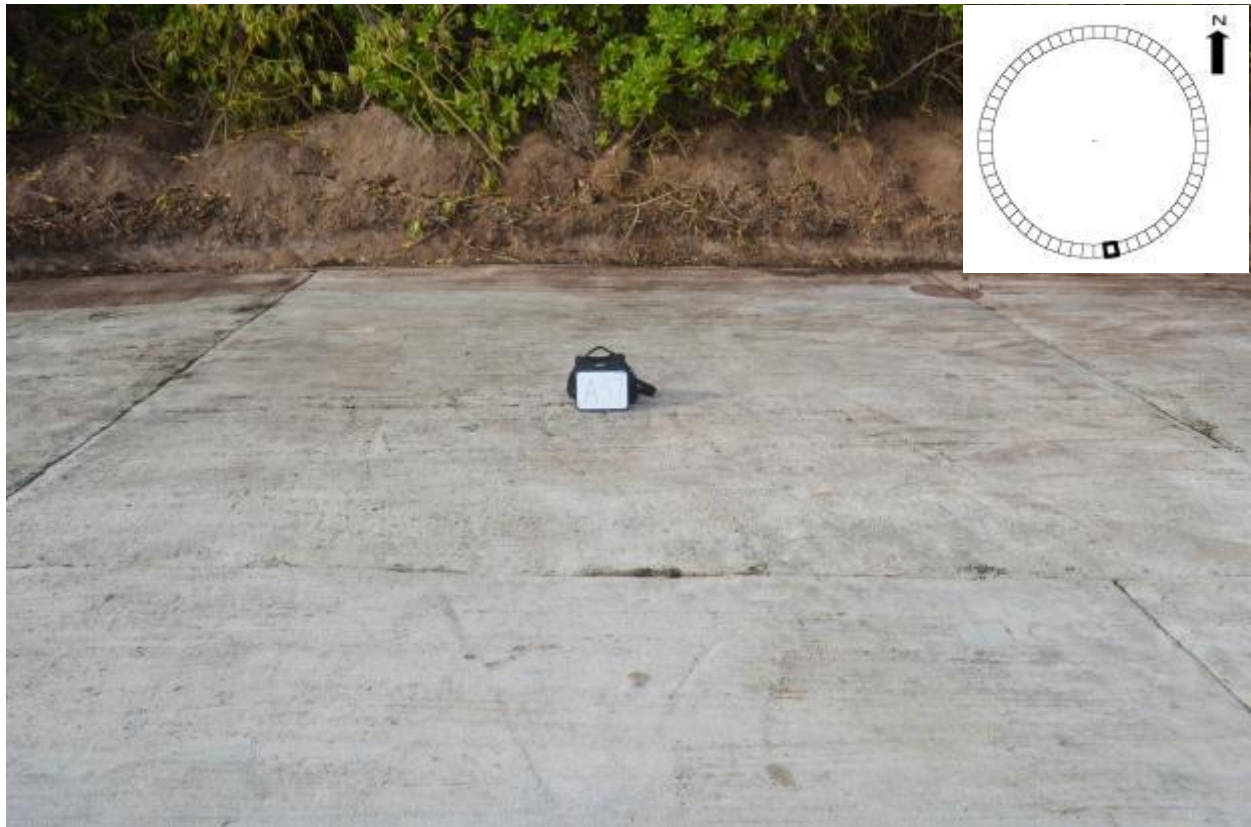
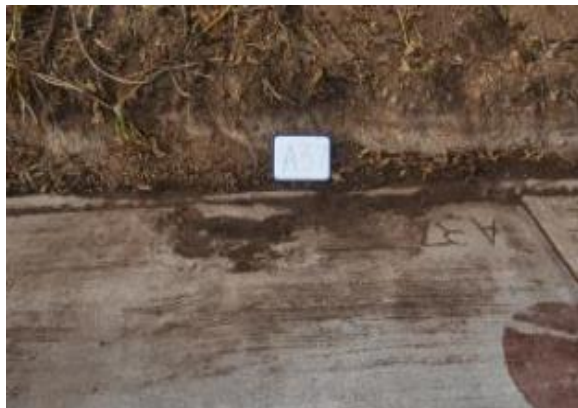
The panel has a relatively rough and weathered appearance. Some minor spalling of concrete observed along the upper right seam of the panel. Significant spalling of concrete observed in the lower left-hand corner of the panel with the chipped out section extending more than 1 meter along the seam. Panel contains a vertical elevation benchmark.

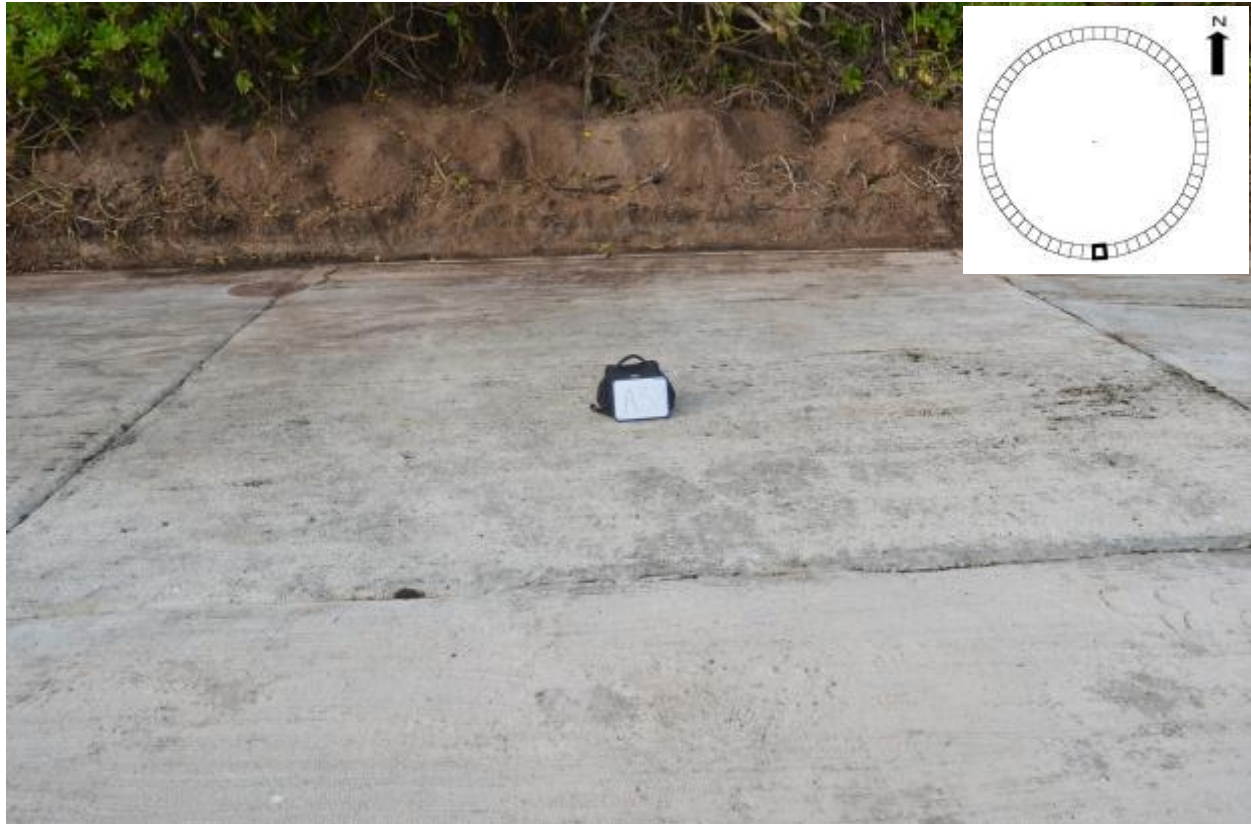
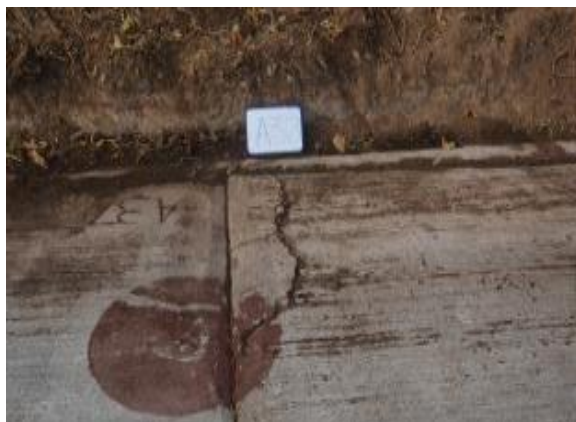
CAP SECTION LOCATION: Panel A38

The panel has a relatively rough and weathered appearance. A crack with spalled edges observed in the lower right-hand corner of the panel extending up about 20 to 25 centimeters inside the seam for a distance of about 1 meter.

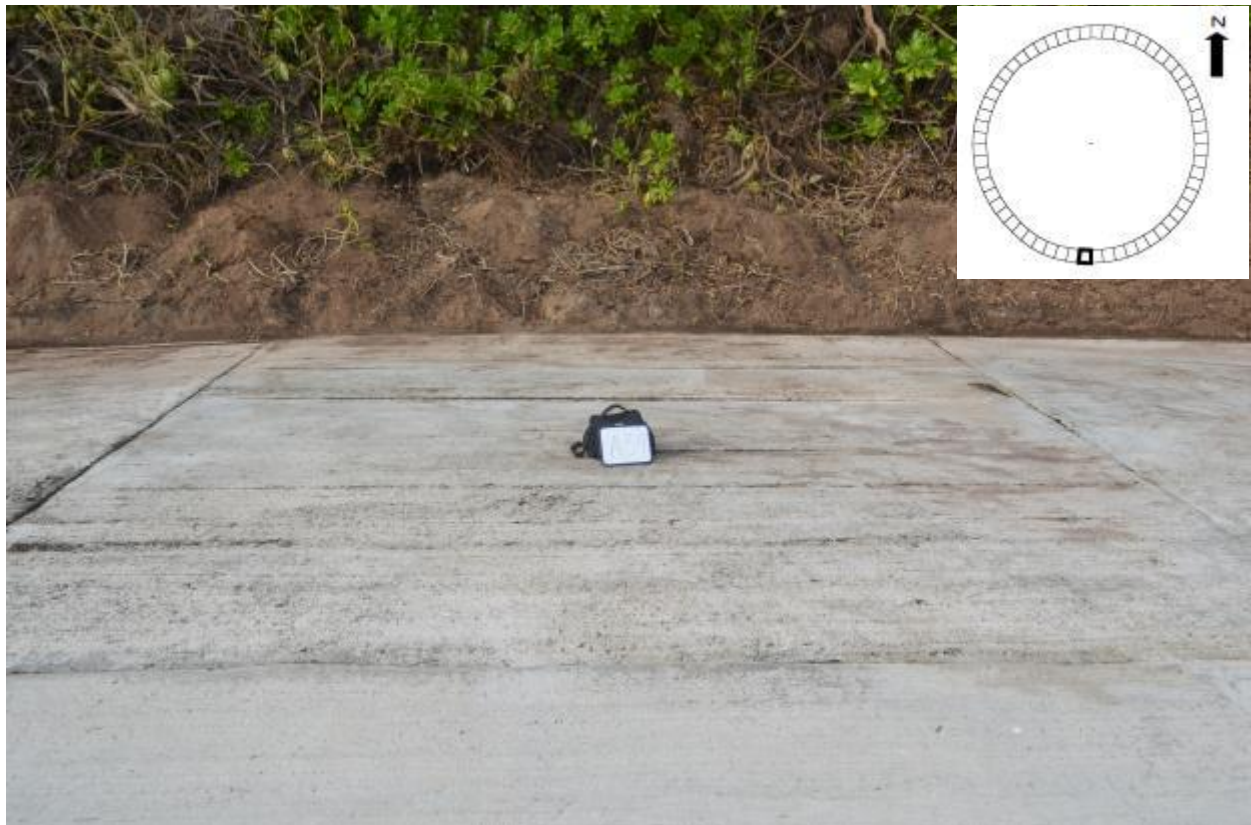
CAP SECTION LOCATION: Panel A39

No significant or obvious interior cracks extending across the top of the panel. The panel has a relatively rough and weathered appearance. Minor spalling observed in the upper left-hand corner of the panel.

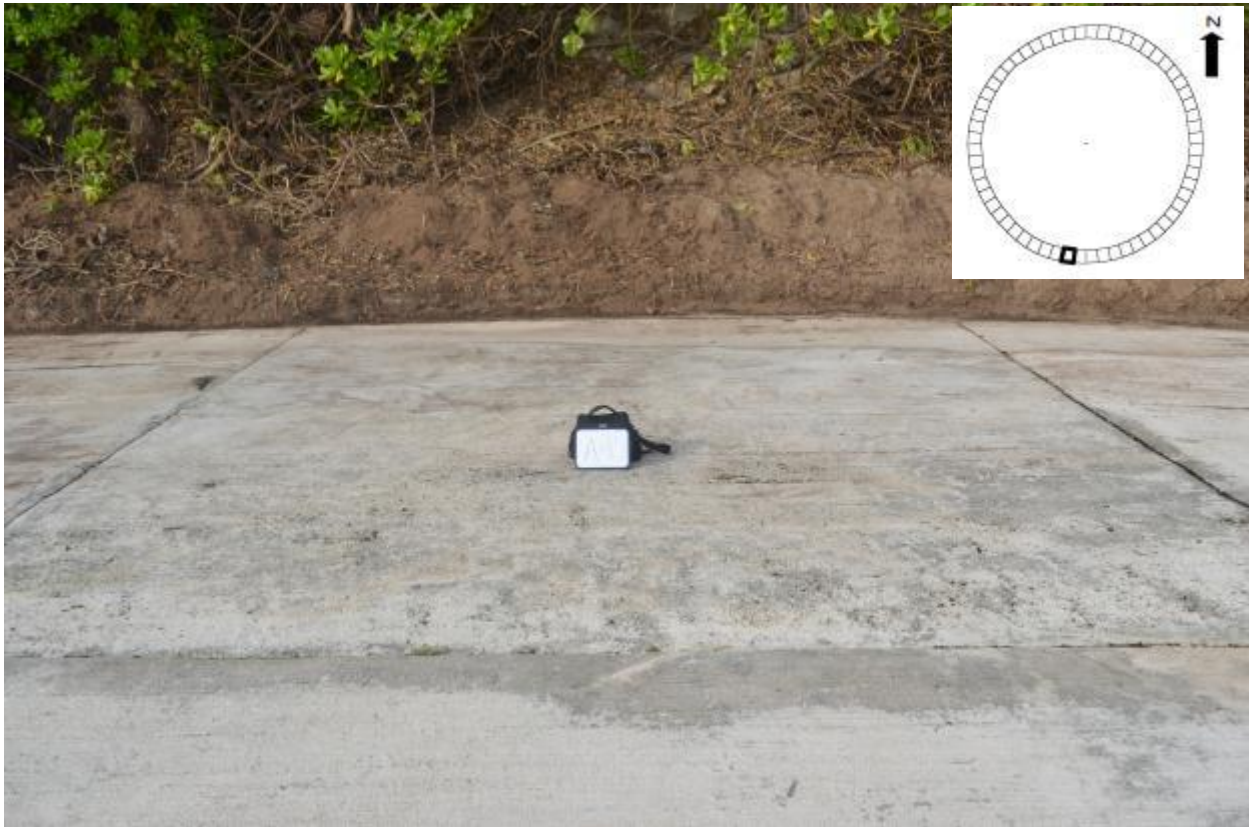
CAP SECTION LOCATION: Panel A40

No significant or obvious interior cracks extending across the top of the panel. The panel has a relatively rough and more weathered appearance. Rooting vegetation removed from along the panel seams.

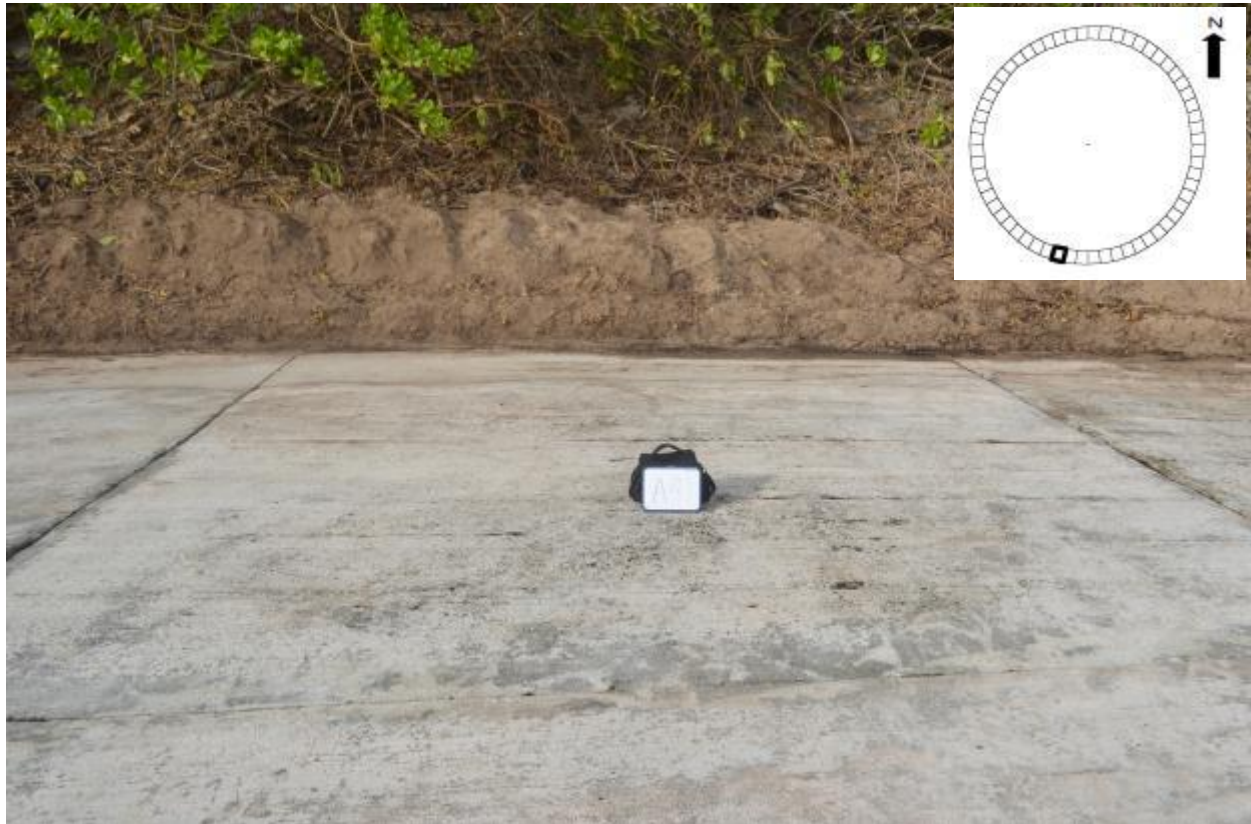
CAP SECTION LOCATION: Panel A41

No significant or obvious interior cracks extending across the top of the panel. Panel has a slightly more rough and weathered appearance. Minor spalling of concrete observed in the upper left-hand corner of the panel. Rooting vegetation removed from along the panel seams.

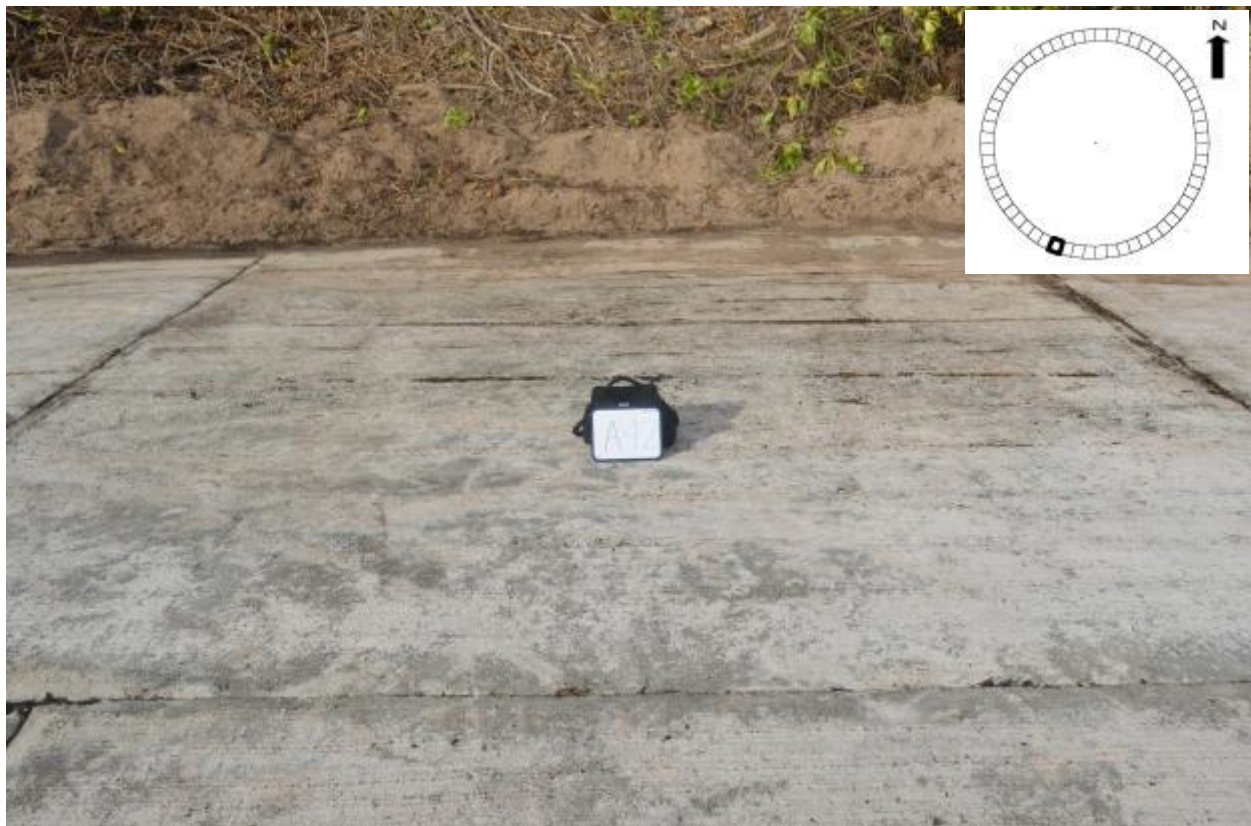
CAP SECTION LOCATION: Panel A42

No significant or obvious interior cracks extending across the top of the panel. The panel has a relatively rough and more weathered appearance. There is an indication from the GPR data that some areas under the panel are poorly supported or “voided”.
